CEMENT GROUTED BITUMINOUS MIXES

Cement Grout Bituminous Mix (CGBM)

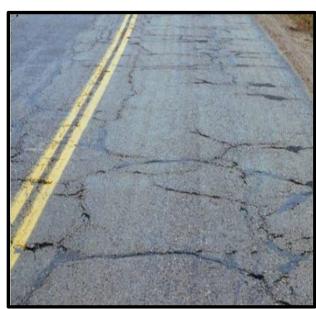
Cracking

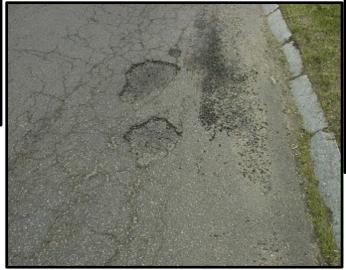
Moisture induced damage

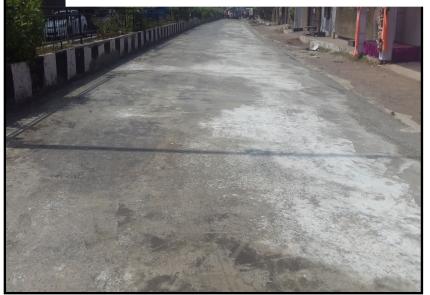
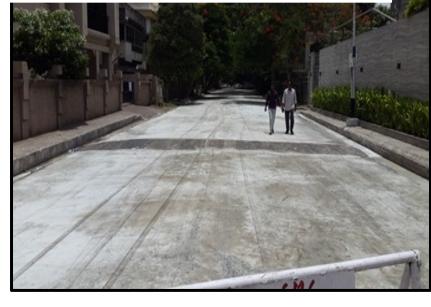
FINISHED SURFACE (AFTER 2 DAYS OF

CONSTRUCTION)

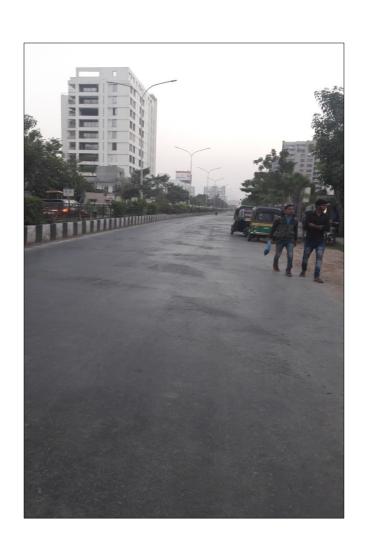
View of two Sections after 6 Months

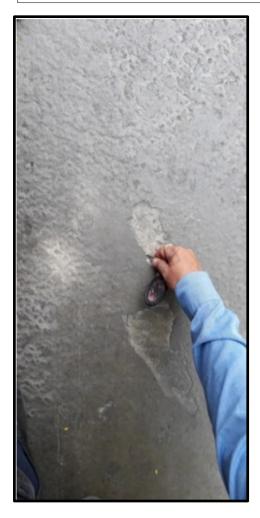
after two months

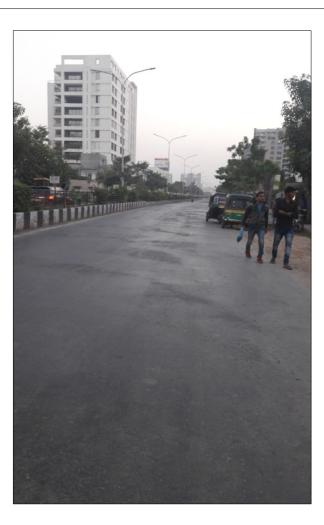
after six months

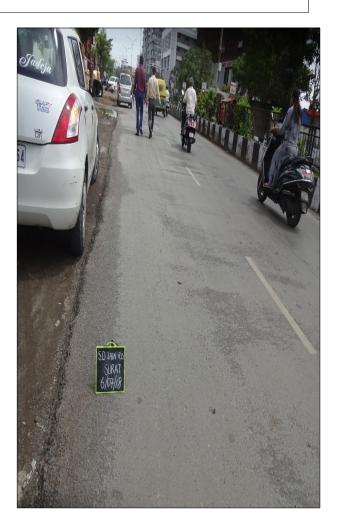
after one year

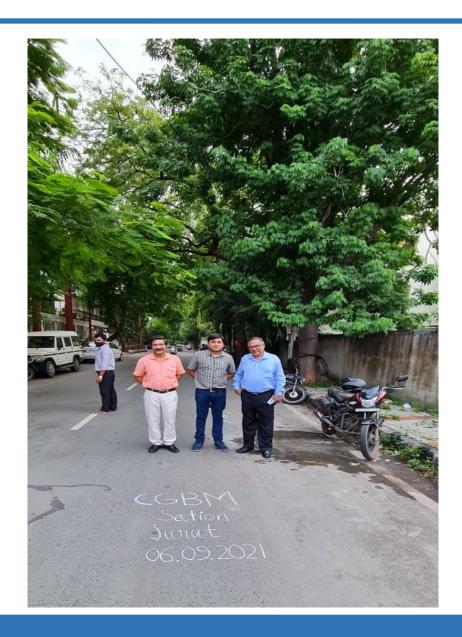
CGBM section after 5 Mansoon
