Grameen Sampark

Pradhan Mantri Gram Sadak Yojana

In this Issue

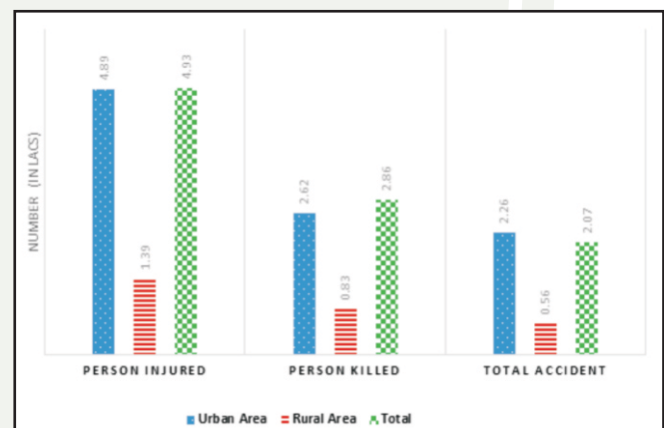
Fig 1-Comparison of Road Accidents in Urban and Rural Area of India (in the Year 2014) (MORTH,2014)

According to the MORTH, 61% of the RTI fatalities occur in rural areas and it is possible that a larger number of cases go unreported on PMGSY roads. Number of accidents in rural areas (2, 66,231) larger being 53.5% compared to urban areas (2, 31,455) at 46.5%. In fact the percentage of injured persons (59.4%) is also higher. Similarly rate of fatalities (63.4%) being even higher. The percentage share of accidents in rural areas and urban areas were 53.7 and 46.3 respectively. Figure 1 presents the comparison of number of accidents in rural and urban areas in the year of 2014 in India.

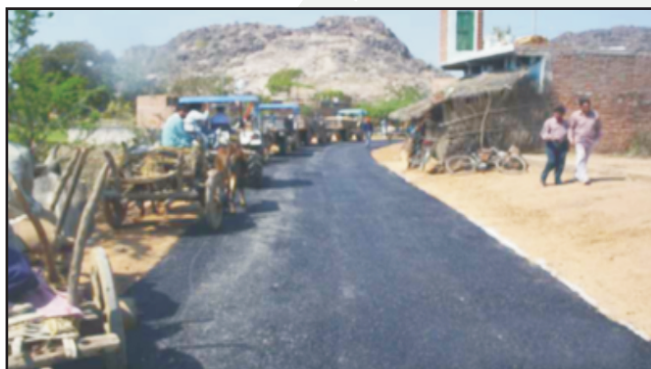
Photograph 1- Habitation along PMGSY Roads creates Hazards to Road Safety

- Habitation, schools, market etc. near PMGSY roads creates road safety hazards and make accidents prone locations. Photograph 1 illustrates the habitations near road creates safety hazards condition.

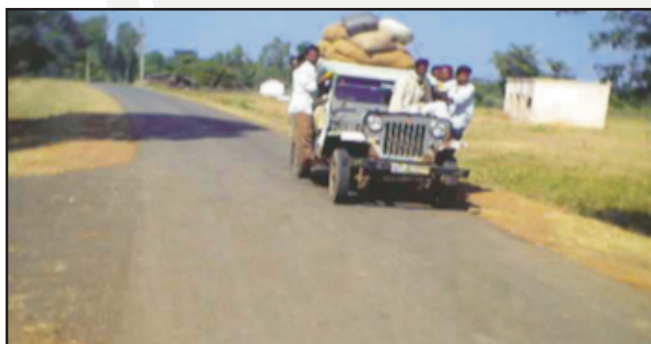
Photograph 2 - Overloading of Passenger Vehicles is another Safety Issue on PMGSY Roads

- Over loading of passenger vehicles, Poor Vehicle Condition, over speeding, are also road user behavioral problems which may cause the road accidents. Photograph 2 illustrates the overloading that can cause the serious road accident.

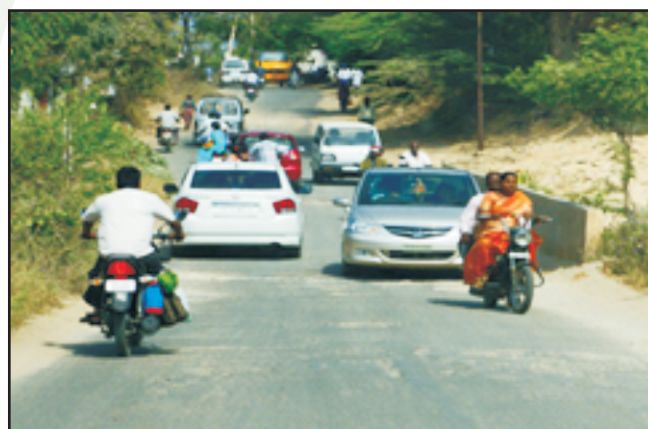
Photograph 3 – Narrow road width may provoke accidents during overtaking-A Safety Issue on PMGSY Roads

- Cattle and animals crossing roads, especially during nights may suddenly obstruct the road and can cause the severe accidents.
- Narrow culverts, bridges and absence of railings increase the probability of vehicles to fall in culverts.
- In PMGSY Roads, users use same narrow road of single lane width with mixed traffic condition, which makes the overtaking operation phenomena more unsafe. Also overtaking whenever carriage way is blocked by animal drawn vehicles / herds of cattle is dangerous and can provoke the accidents. Photograph3 shows the mixed traffic condition at single lane may provoke accidents while overtaking.

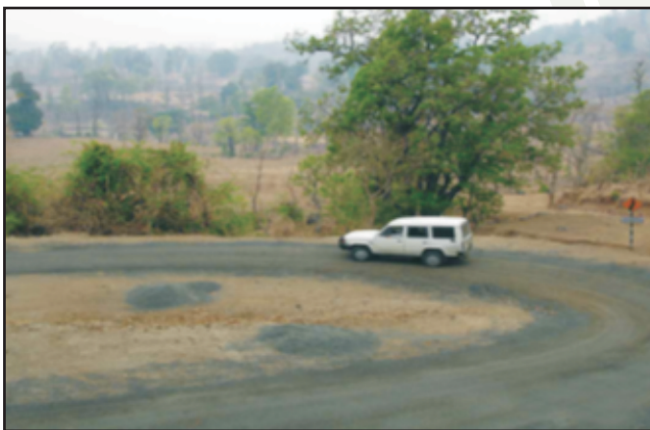
Photograph 4 - Road Safety Hazards due to Sharp Curves on PMGSY Road

- Lack of Super-Elevation at sharp curves possibly creates safety hazards conditions. Photograph 4 illustrates the safety hazards condition due to sharp curves at PMGSY roads.

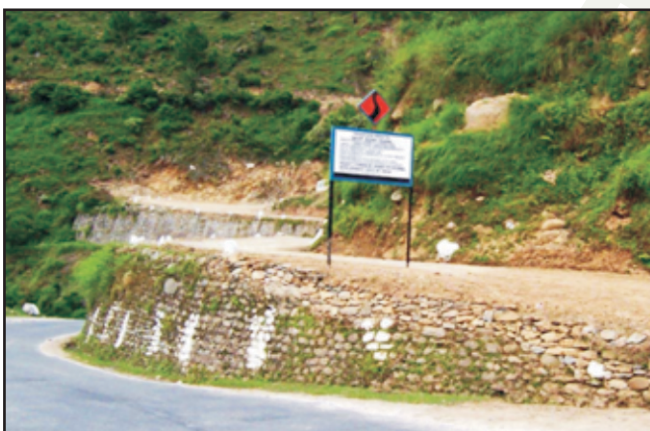
Photograph 5 - Improper Sight Distance- A Safety Hazardous Condition at PMGSY Roads

- Improper sight distance at sharp curves due to trees, vegetation and other obstruction creates accident prone locations and increases the road safety hazards condition at PMGSY roads. Photograph 5 illustrates the improper sight distance due to obstruction at PMGSY roads which creates the safety hazards condition.

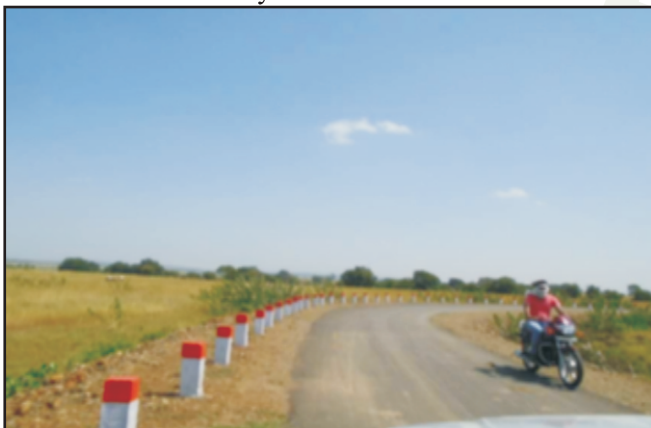
Photograph 6- Guard Stone provided at Sharp Curves enhances safety on PMGSY Roads

horizontal curves. Further, proper super elevations, cautionary boards and extra widening should also be provided at curves to enhance safety. Photograph 6 illustrates the provision of guard stones at sharp curves to enhance safety at PMGSY roads.

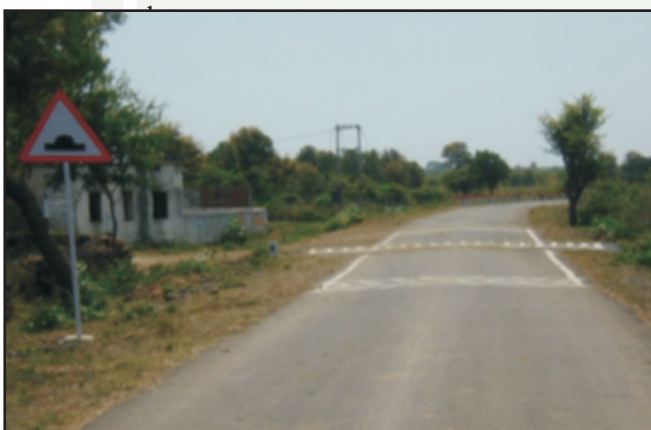
Photograph 7 –Provision of Road Humps near schools, Habitations etc. Enhances Safety

- Junctions of PMGSY roads with main road needs be designed by providing minimum turning radius, flaring of the side road, acceleration/deceleration lanes and adequate sight distances etc.
- Safety near habitation and schools can be enhanced by providing adequately designed road humps, rumble strips, warning signs, habitation sign boards etc. Photograph 7 illustrates that provision of speed humps near habitations may enhance safety at PMGAY

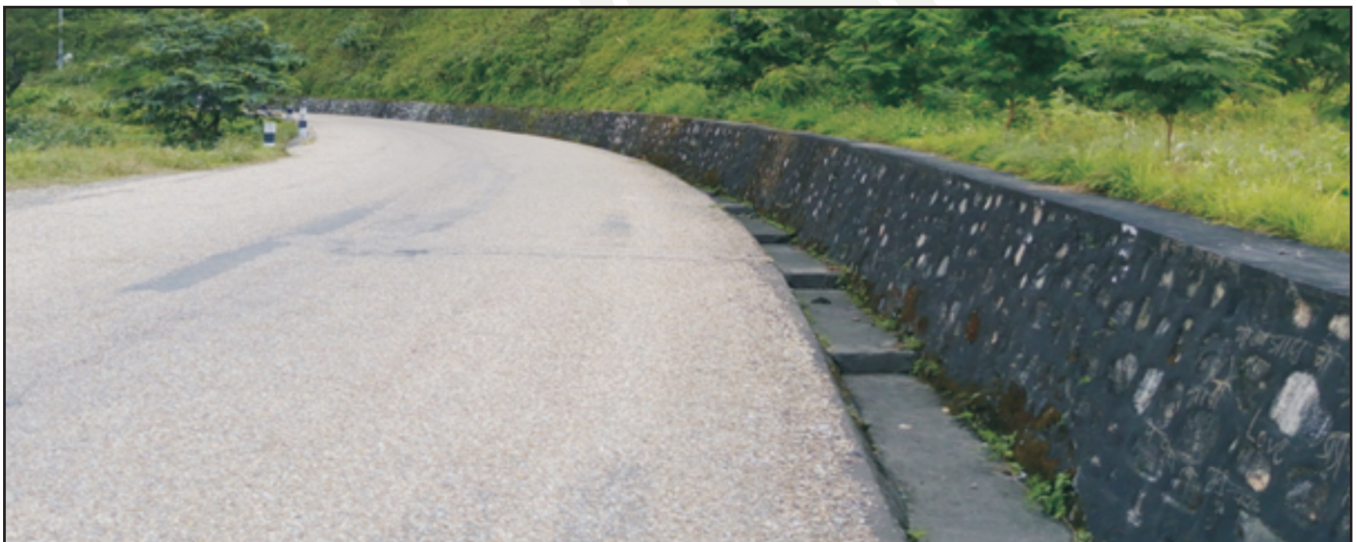
Special emphasis should also be given while construction of longitudinal drainage and cross drainage structures so as to tame and drain off the surface runoff intercepted by the road. Longitudinal drains are best constructed in steps so as to reduce scouring of the lining of the drain surface by taming the velocity of the water flowing through it. Accordingly sufficient drops with cover should also be provided at the outlets of cross drainage structures.

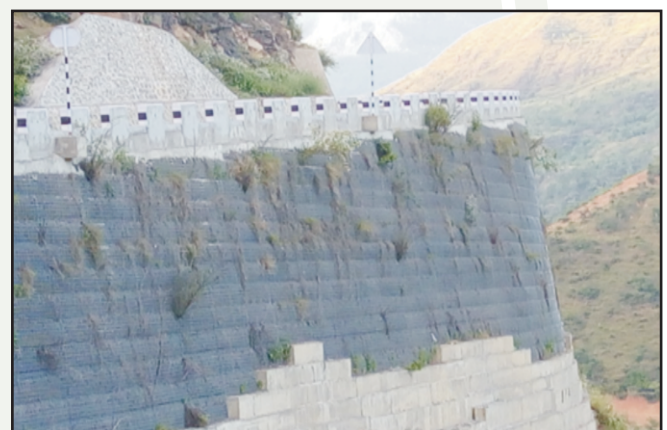
A wire mesh is erected for containing/retaining the earth which in turn is drawn towards the hill by high tensioned wire cables and is bolted. The filling is done with reinforced soil in layers and compacted.

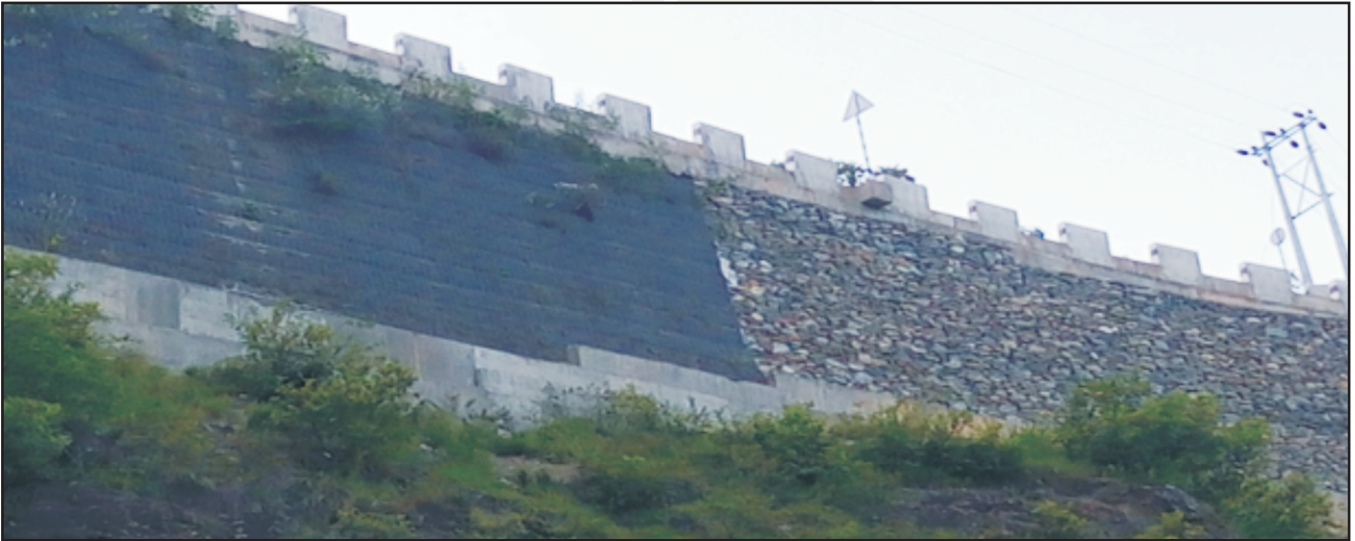
b) Gabion retaining walls with or without the use of Geo-synthetics,

In the above picture it can be seen that gabion structure has been put up for retaining the earth used for filling for achieving the desired road formation

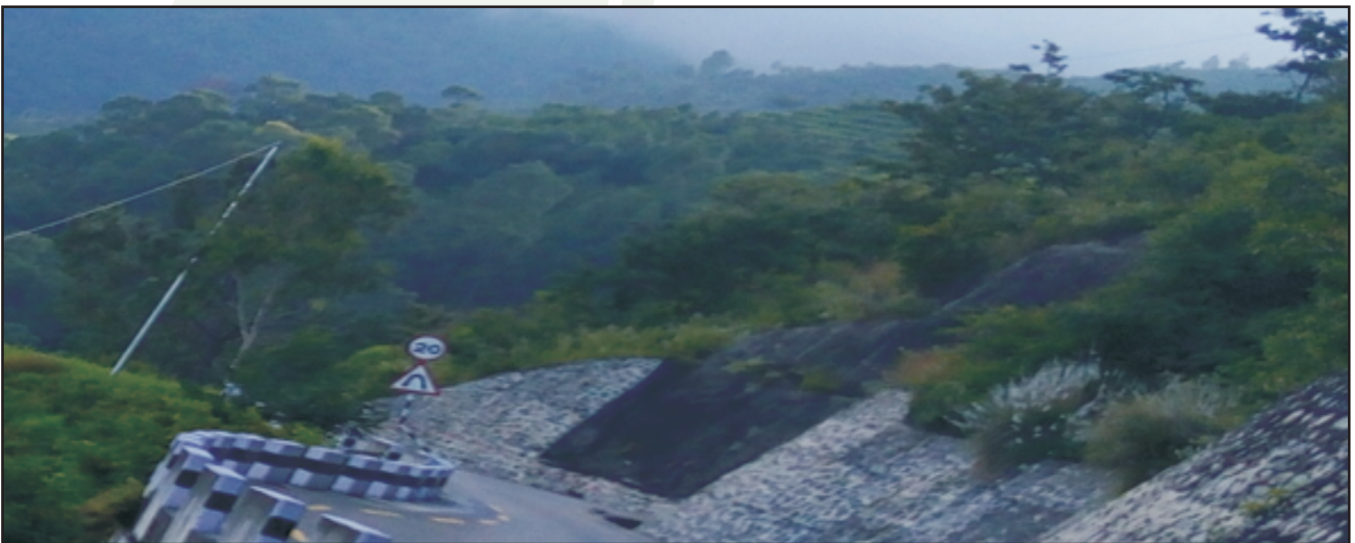
d) Shotcreting,

A section of the hill side is stabilized by shotcreting. It was found used in many stretches.

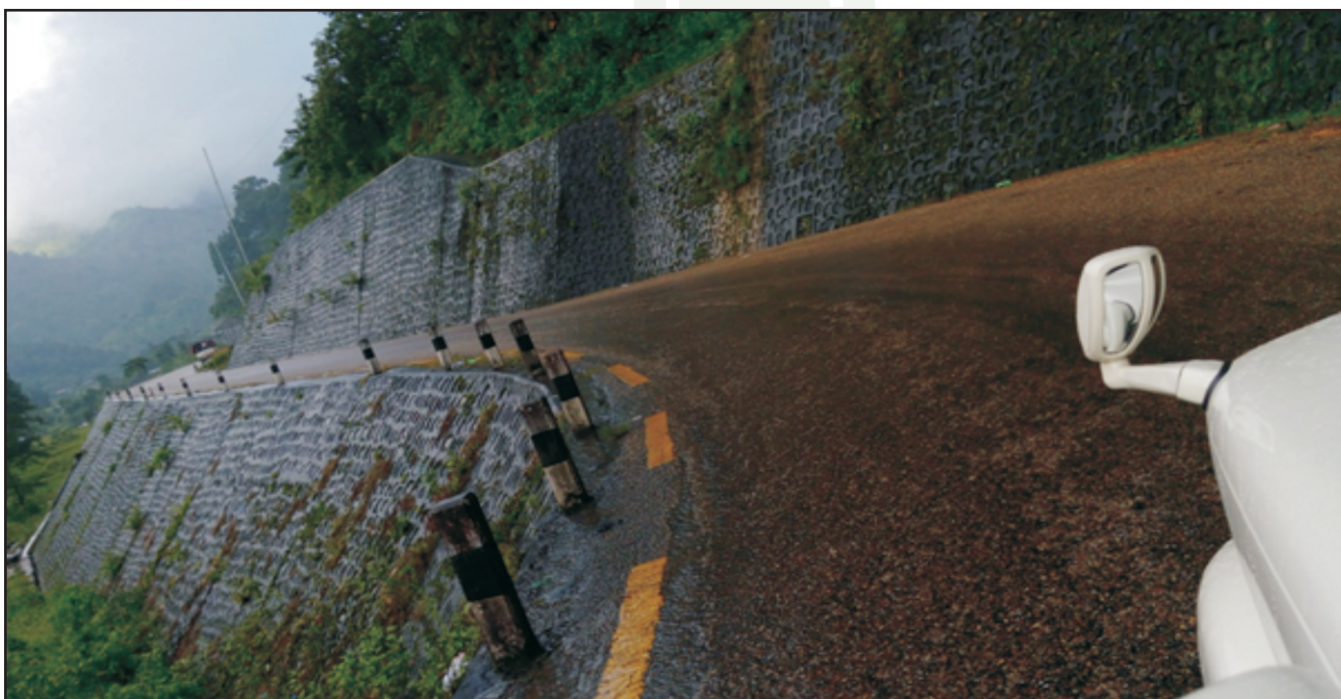
f) Masonry/RCC skin walls

This particular type of wall was found used extensively all along the route for stabilization/prevention of erosion of the hill side slope. This particular wall does not retain or take any kind of load. This is laid as a lining and thus follows the slope of the hill. The section of the wall is usually about 0.6m thick throughout. As shown in the picture above it has also been used to prevent erosion of embankment along the valley side.

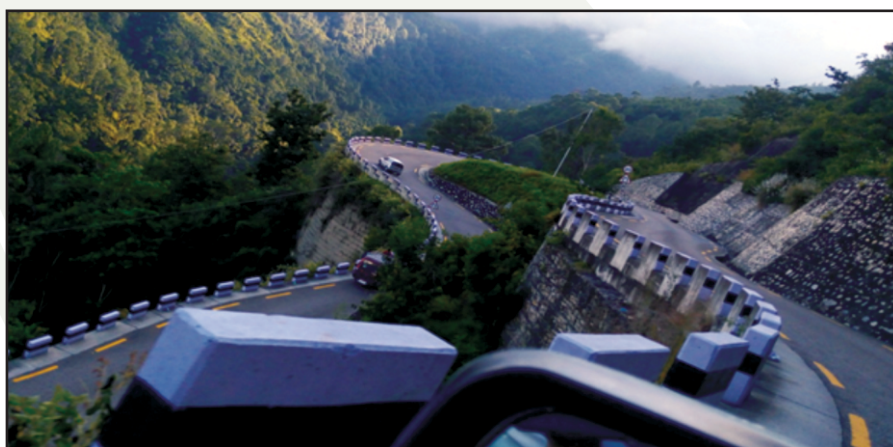
Below illustrated are few of the photographs of one of the route that was selected for study that had made use of all the above mentioned techniques for construction:

It was found that the proper geometry was maintained along the routes with proper gradient and radius of curvature along major circular curves/hair pin bends. The minor curves were not found improved and they followed the natural profile of the hills as it is.

The gradient along the straight reaches were found to be that of limiting and exceptional gradient thus avoiding mass scale cutting of hills. For that matter it was also observed that the hill cutting along the entire stretch was kept to bare minimum and the road formation was found achieved by way of construction of walls of different types, thus restricting the damage to the environment/hills to the minimum. The road is found to be constructed adopting cut and fill technique with skin walls, Breast walls and Retaining walls throughout the stretch.

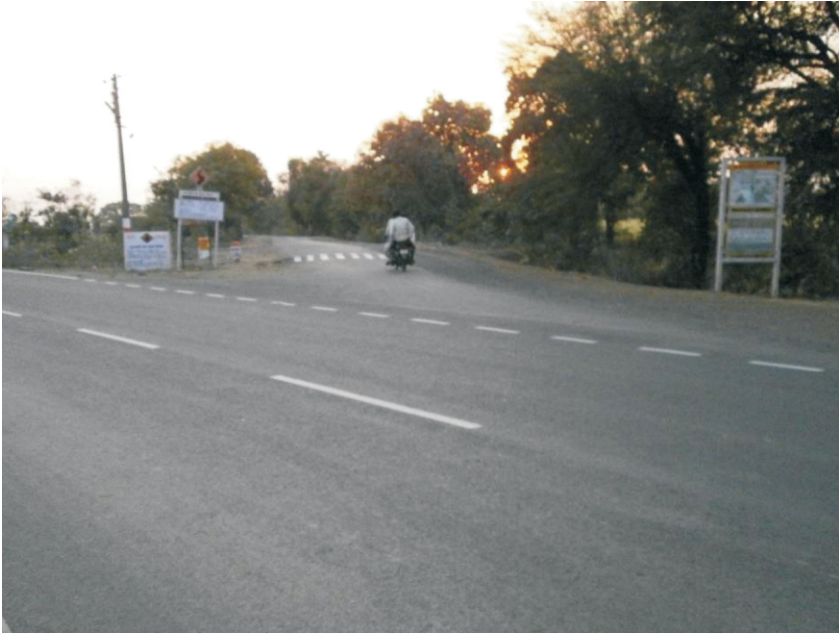
S. No.	Issue	Images	Remarks
1.	Flare at the start point of the road

When the rural road meets higher category road, proper flare for increasing visibility have been provided. Further, Speed Breaker and Cautionary Boards have also been provided as mitigation measures on PMGSY roads.
2.	Speed Breakers

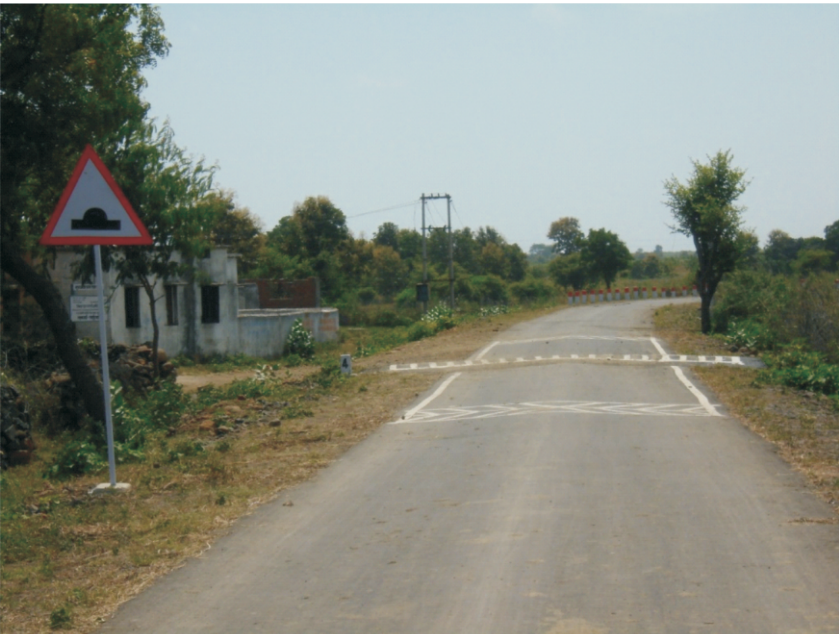
Speed Breakers are provided with information boards at locations near school and start of habitations on all PMGSY roads.

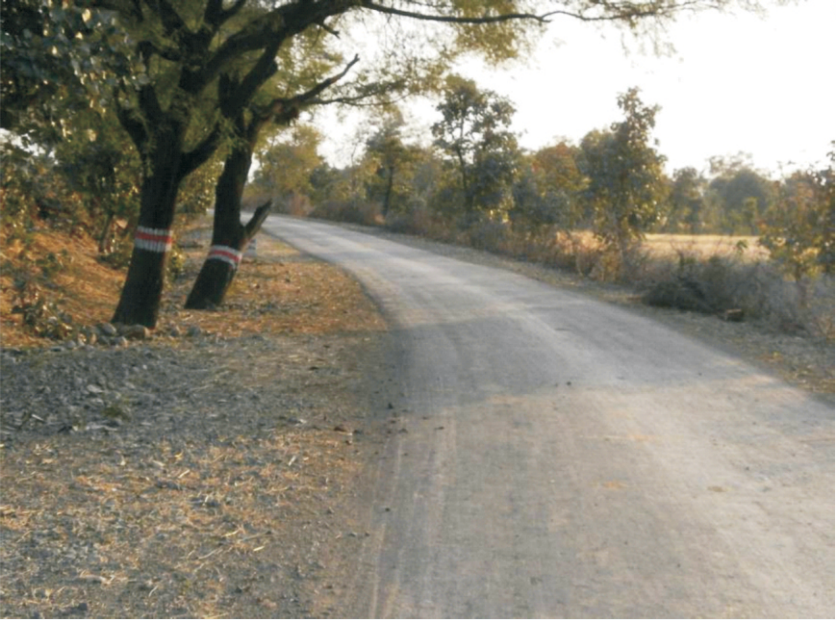
S. No.	Issue	Images	Remarks
3.	Measures relating to Trees on the roadside

<p>Trees and Electric Poles on the shoulders are regularly painted in black and white layers to increase the visibility at night.</p>
5.	Wells situated adjacent to roads	 	<p>Wells at critical locations are protected with proper protection walls.</p>

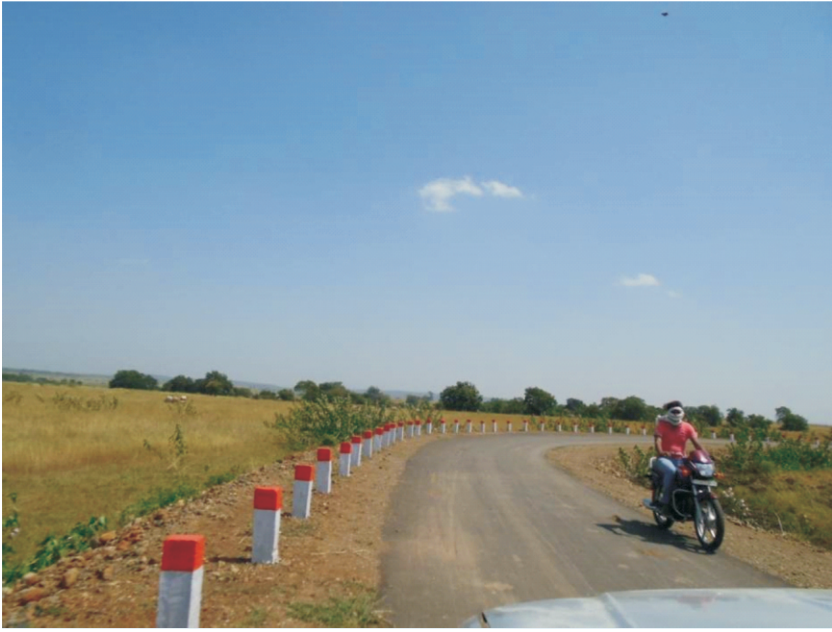
S. No.	Issue	Images	Remarks
6.	Guard stones

<p>Guard Stones are provided on the sharp horizontal curves. Further, proper super elevations, cautionary boards and Extra widening has also been provided at curves to prevent any kind of accidents.</p>
7.	Road Markings

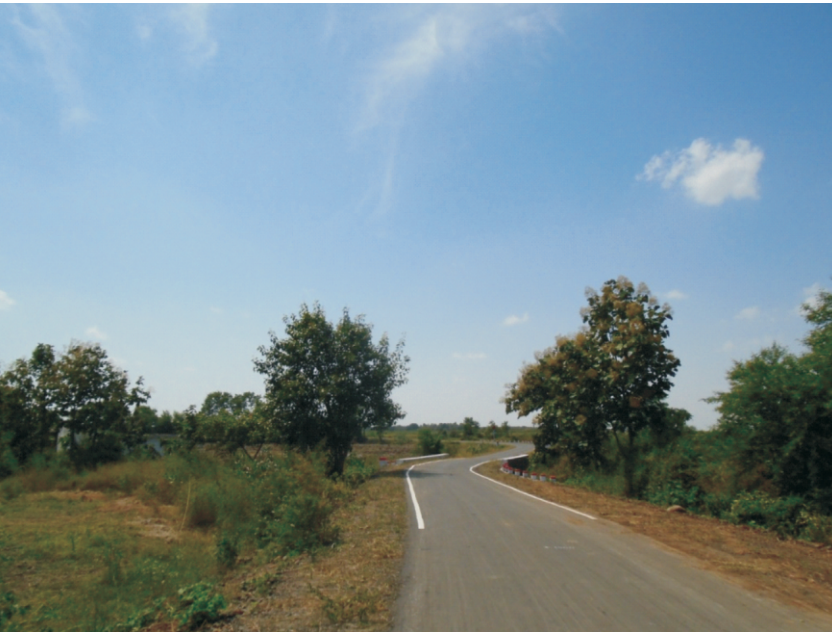
<p>Road Markings at edges have been provided to alert the drivers in the night time about the carriage way lines on all PMGSY roads.</p>

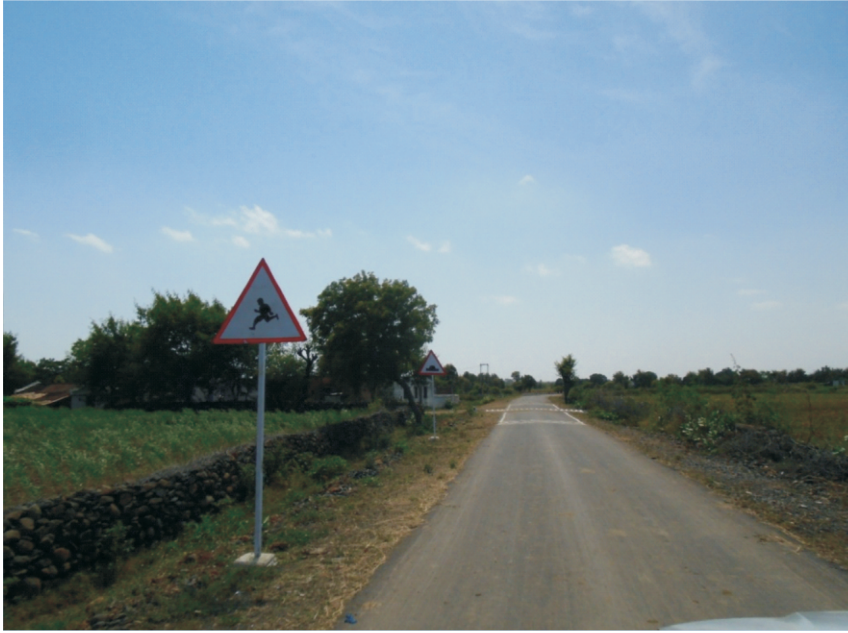
S. No.	Issue	Images	Remarks
8.	Speed Control near Schools and Habitations

Proper sign boards and Speed breakers have been provided before schools and Habitation to ensure safety of foot traffic and to ensure speed regulation.
9.	Warning Boards

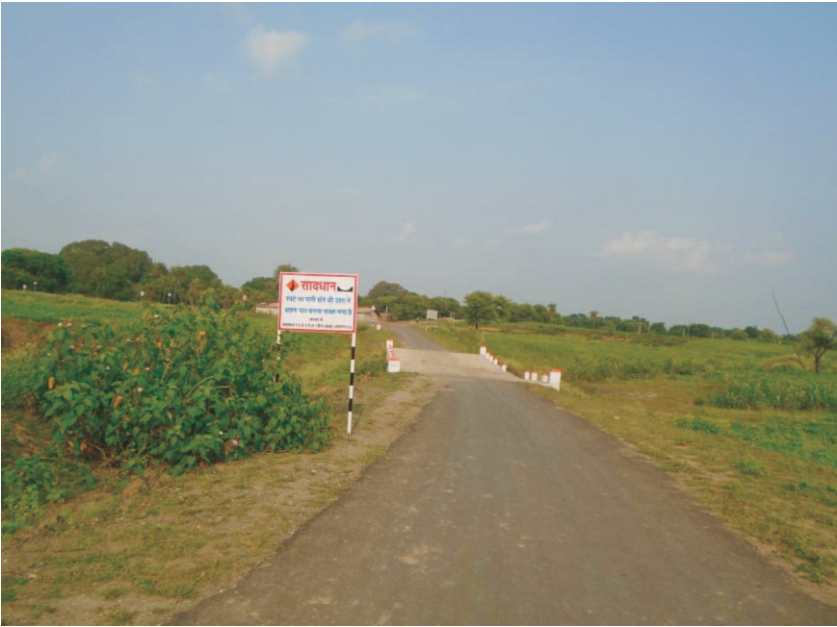
Warning boards on Cross Drainage (CD) works, to alert the drivers not to cross the paved under water during rainy season/ floods.

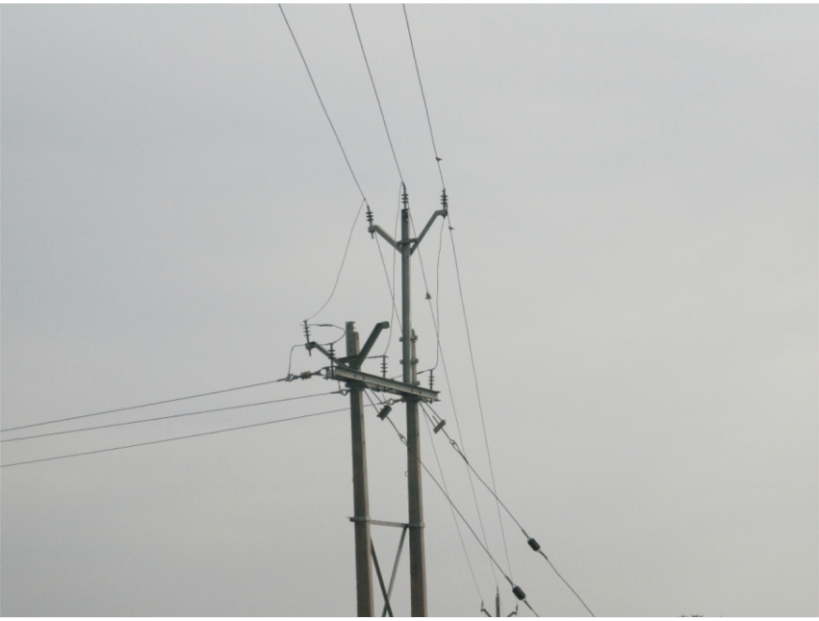
S. No.	Issue	Images	Remarks
10.	Electronic Line Crossings (ELC)

Increasing the height of ELC to provide proper vertical clearance done, wherever required
11.	Habitation Name Board

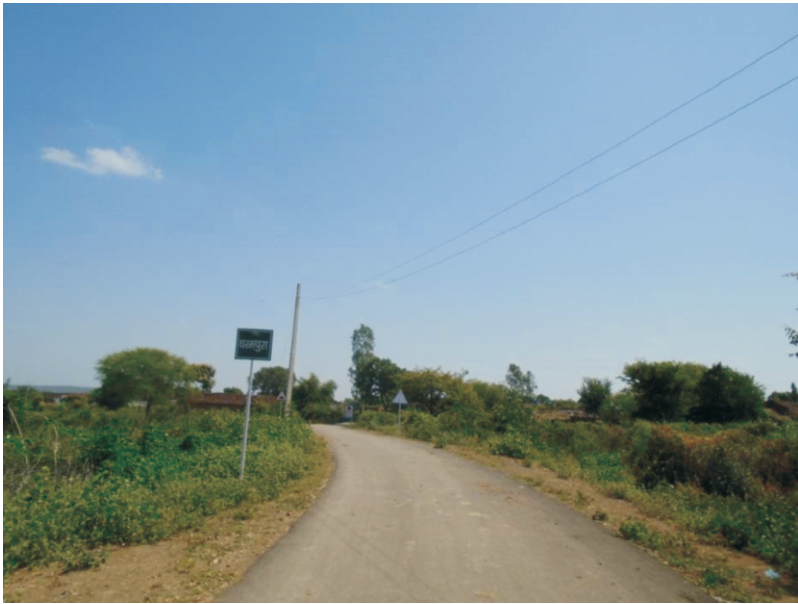
Habitation Name Boards before the Habitation erected all PMGSY roads.
